East Fork Lewis River Watershed

Bacteria Monitoring and Nonpoint Source Identification

Washington State Department of Ecology

Publication 21-10-003

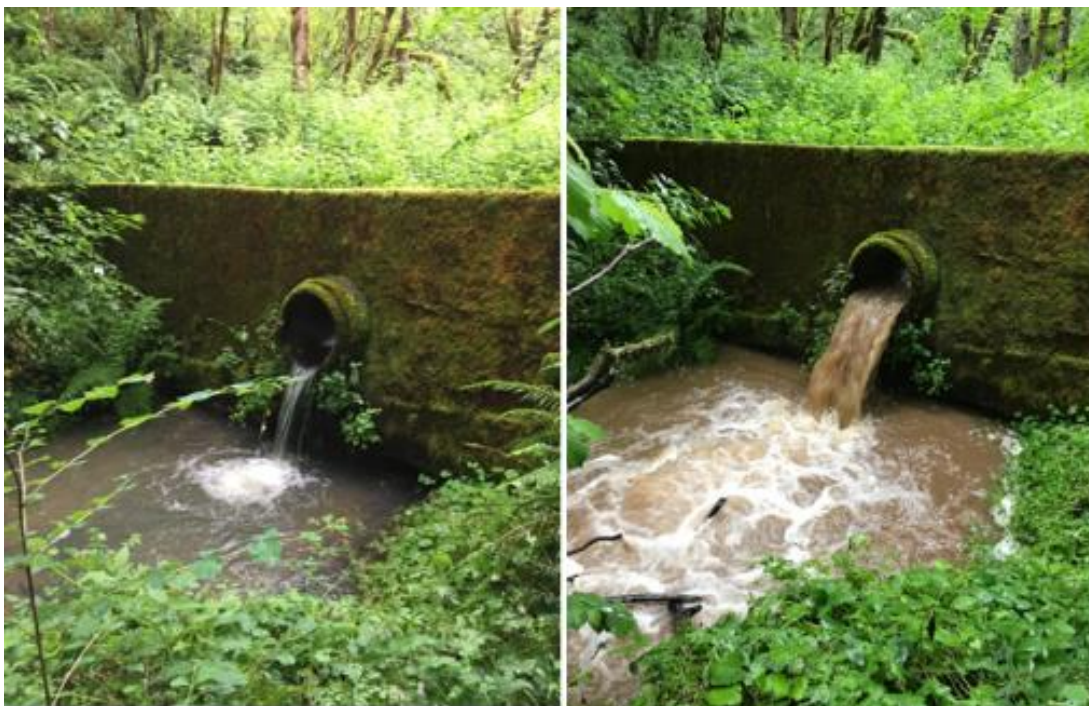
Data from areas not previously monitored, such as Bolen Creek, showed high bacteria levels in new locations in the watershed. This new information highlights the importance of further investigation in the watershed to find other areas of concern. The results also indicated Bolen Creek may be impacted by agricultural runoff from the nearby rural landscape and by the stormwater runoff from the City of La Center, since this creek had the highest bacteria levels compared to most sites following a heavy rainfall.

Figure 6. Photos of Bolen Creek site BCK-0.46 taken by Shawn Ultican, nonpoint source specialist, on June 10, 2020 (left) and June 15, 2020 (right) following heavy rainfall. Bolen Creek had the highest FC and *E. coli* results out of all sites on June 15.

- Upstream of Jenny Creek site JEN-2.8.
 - Upstream of Bolen Creek site BCK-0.37.
 - Upstream of Brezee Creek site BRZ-5th.
- Continue source identification and illicit discharge detection and elimination efforts to detect pollution sources within the Brezee Creek stormwater system.

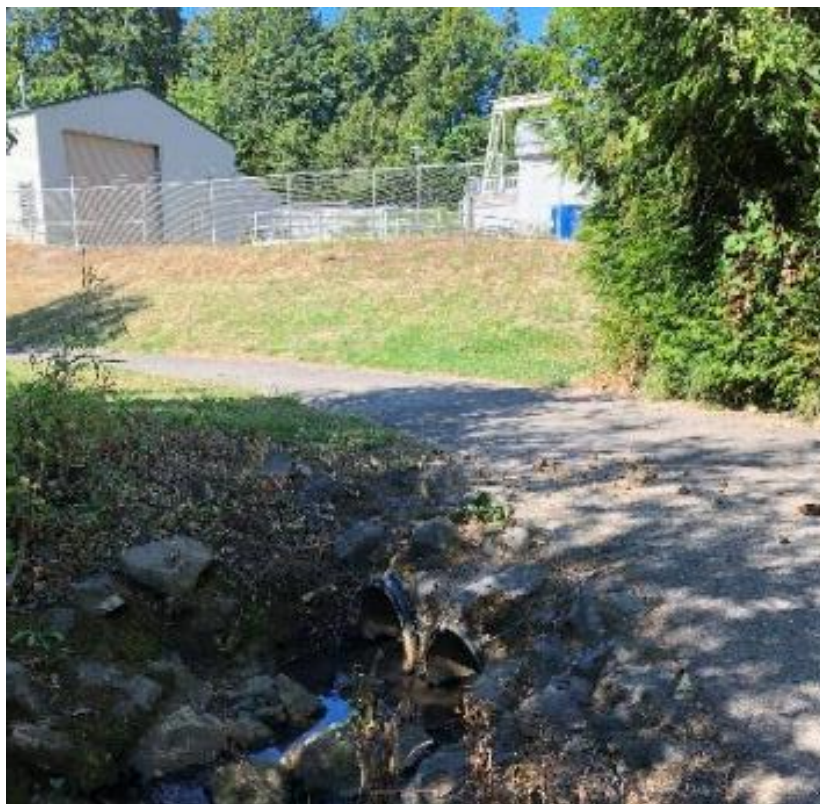
There was clear evidence of nonpoint sources of bacteria around the area just from field observations. As an example, horse waste was found on pavement in Sternwheeler Park directly above the lower Brezee Creek culvert (BRZ-SW2) during a sampling event for this study (see Figure 7). There is high potential for this waste to be directly discharged or washed into the creek and contribute to bacteria pollution in Brezee Creek and the EF Lewis River. This further emphasizes the importance of pet waste management in these urban areas.

Figure 7. Photo of horse waste taken by Molly Gleason above sample site BRZ-SW2 with La Center Waste Water Treatment Plan in the background taken on August 24, 2020.

- Implement urban stormwater management and appropriate BMPs to reduce water quality impacts within the Brezee Creek stormwater system.
- Utilize inter-agency partnership collaborations and PIC program tools to work towards addressing nonpoint source bacteria issues associated with septic system and agriculture.
